Re: Dioxin in the San Jacinto River at the Interstate Highway-10 Bridge

Maps and Aerial Photographs of the San Jacinto River at I-10

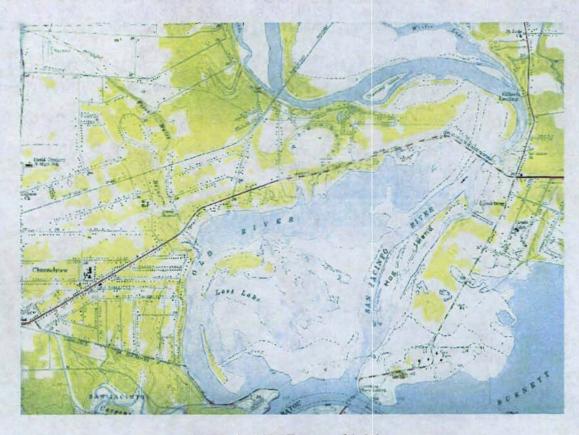
Figure 1. 1955 Topographic Map

This sequence of maps and photos shows the history of this area of the San Jacinto River. The 1955 topographic map shows a clearly delineated channel of the San Jacinto River prior to subsidence. Note that no waste pits appear on this map. The 1967 topographic map shows what could be waste pits just north of the I-10 bridge. In the 1982 topographic map and aerial photograph, much of the land area north of I-10 has been submerged due to subsidence.

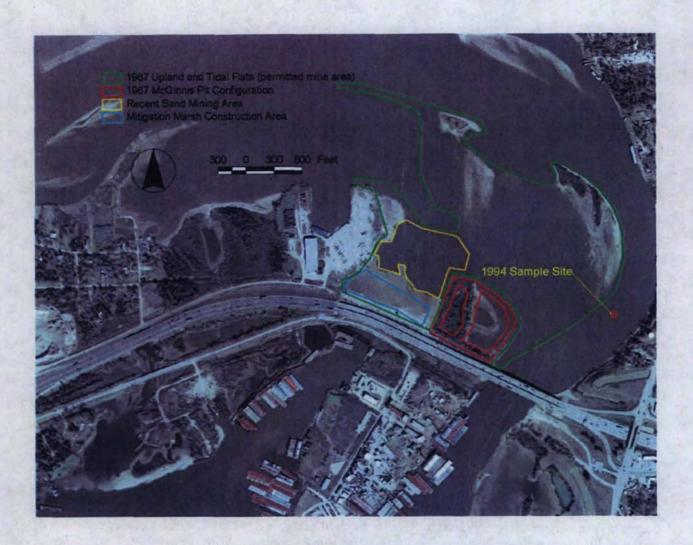
Figure 5. 2005 Aerial Photo

In Figure 5, the green polygon shows the general presubsidence upland and tidal flat configuration. This outlined area, excepting the two islands, is permitted for additional sand mining under USACE permit 19284(03), which is in the process of being renewed. The tan polygon indicates the area recently dredged for sand. The sand was processed on the adjacent high ground and much of the finer sediment (silts and clays) has washed back into the excavated hole. The blue polygon indicates where clayey material from the mining was placed and is now being spread out onto the existing tidal flat to create a marshland as required by USACE permit 19284(03). The red polygon shows the approximate configuration of the waste pit as depicted on the 1967 topographic map. The red circle indicates the approximate location of the 1994 sediment sample point that had high dioxin levels.

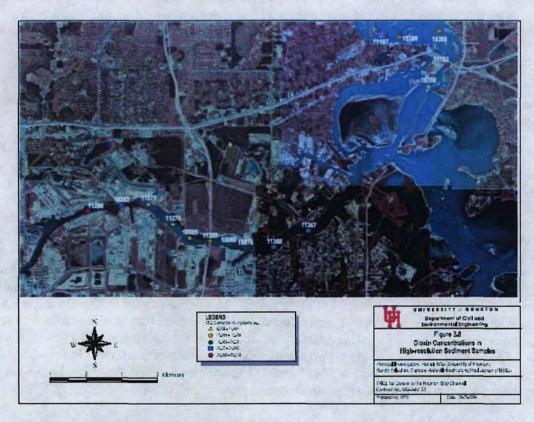
Data for summer 2004 sampling were reported in Quarterly Report No. 5 [6]. In summer 2004, shallow and deep water samples were taken in the San Jacinto River at I-10. "Analysis of water samples ... showed consistently higher dioxin concentrations for the deep samples than for the shallow ones" (p. 61). Sediment samples were taken upstream and downstream in the vicinity of station 11193 to try to locate unidentified major sources (p. 31 and Figure 3.8). At station 18389, about 1 kilometer upstream of 11193, and at station 18390, about 1 kilometer downstream of 11193, sediment values were high. "Both 2378-TCDD and TEQ [sediment] levels at station 18389 (~1 km upstream of station 11193) are significantly higher than those observed at the remaining locations in segment 1001, which might suggest the presence of an identified source of 2378-TCDD" (p. 33).

Figure 6. Location of stations used in Summer 2004 sediment sampling. (Figure 3.8 from [6].)
